Brake Pedal (Valve & Treadle Assembly) Inspections

This *Inspection Bulletin* describes inspection procedures for the brake pedal (valve and treadle assembly) on air brake-equipped vehicles.

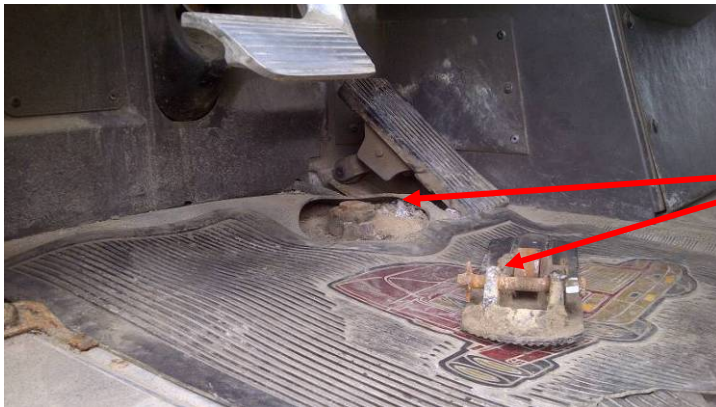
Broken Mounting Plate Ear / Pivot Support

Figure 1: A detached brake treadle illustrates a potential result of excessive corrosion damage.

The mounting plate ears / pivot supports can become damaged from corrosion and eventually even fail. When the mounting plate ear / pivot support on one side has broken off, the treadle can operate somewhat normally. When both mounting plate ears / pivot supports break, the treadle will detach from the mounting plate and valve. These conditions can be identified with a visual inspection.

When inspecting air-braked vehicles with a floor-mounted brake pedal, valve and treadle assembly, visually inspect the condition of the treadle and pivot area of the mounting plate. Some corrosion on these components is normal. (You may want to have the driver get out of the vehicle to inspect the brake treadle.)

1. With brakes released, visually check the condition of the mounting plate ears / pivot supports of the valve and treadle assembly, for cracks or damage.

- a. Confirm that the treadle is properly aligned and in its normal position.
 - b. Confirm that no mounting plate ear / pivot support is broken and both sides are free of cracks and damage.

- c. Ensure the pivot pin is through both mounting plate ears / pivot supports and the pin retaining hardware (cotter pin, ring, clip, etc.) is in place.

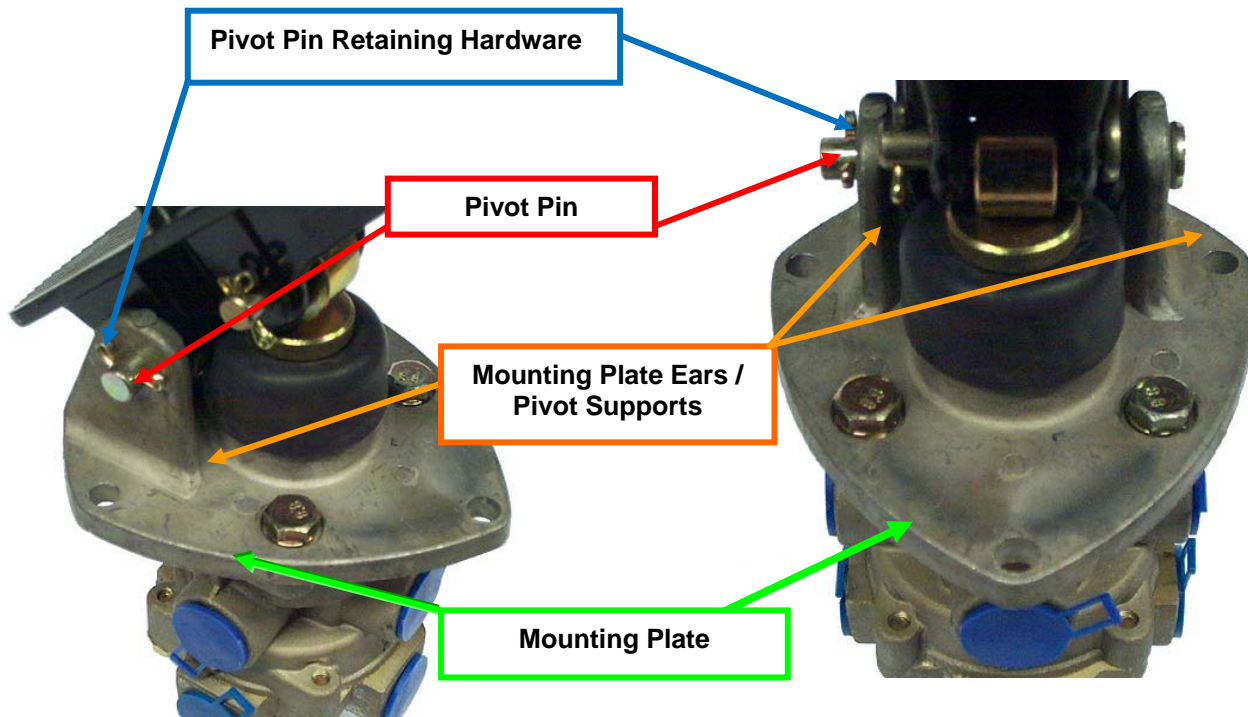
Below are images of an air brake foot valve and treadle assembly with mounting plate in new condition showing the pivot pin, mounting plate ears/ pivot supports, pin retaining hardware and mounting plate locations.
